GEOWORLD

STUDENTS' JOURNAL

VOLUME 13, 2025

DEPARTMENT OF GEOLOGY
TRI-CHANDRA MULTIPLE CAMPUS
TRIBHUVAN UNIVERSITY
DECEMBER 2025

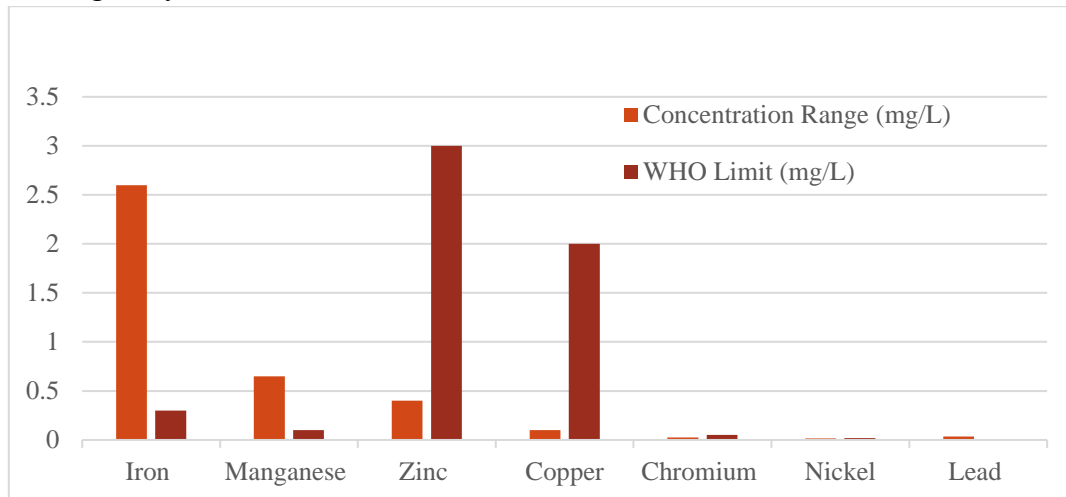
Figure 3: Bar graph of comparison of heavy metal concentration in groundwater samples to WHO limits from Ramkot, Kathmandu (Kandel et al., 2025).

The tested water samples showed a clear pattern, with the highest concentrations of heavy metals being Fe > Mn > Zn > Cu > Cr > Ni > Pb > Cd. Iron and Manganese were the only metals to regularly exceed the WHO and NDWQS limits.

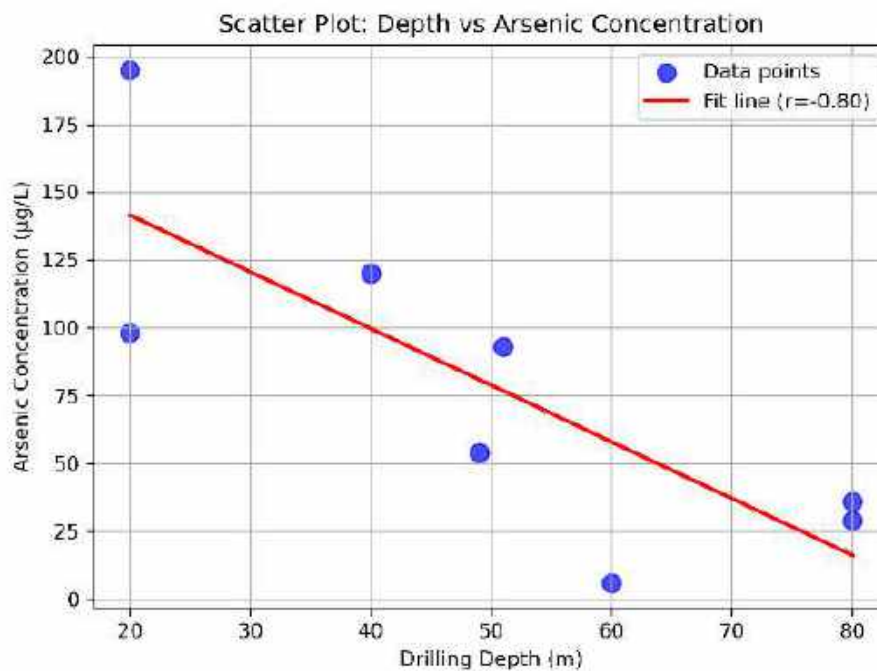
Figure 2: Scatter plot of Depth and Arsenic concentration

The scatter plot (Figure 2) shows that arsenic concentration decreases as drilling depth increases. The fitted regression line confirms a negative linear trend, which is supported by the Pearson correlation coefficient ($r = -0.799$, $p = 0.017$). Shallow wells (15–40 m) show much higher arsenic concentrations, sometimes exceeding 100–190 $\mu\text{g/L}$, whereas deeper wells (>70 m) generally show much lower concentrations (below 40 $\mu\text{g/L}$). This suggests that drilling deeper wells may reduce exposure to arsenic-contaminated water.

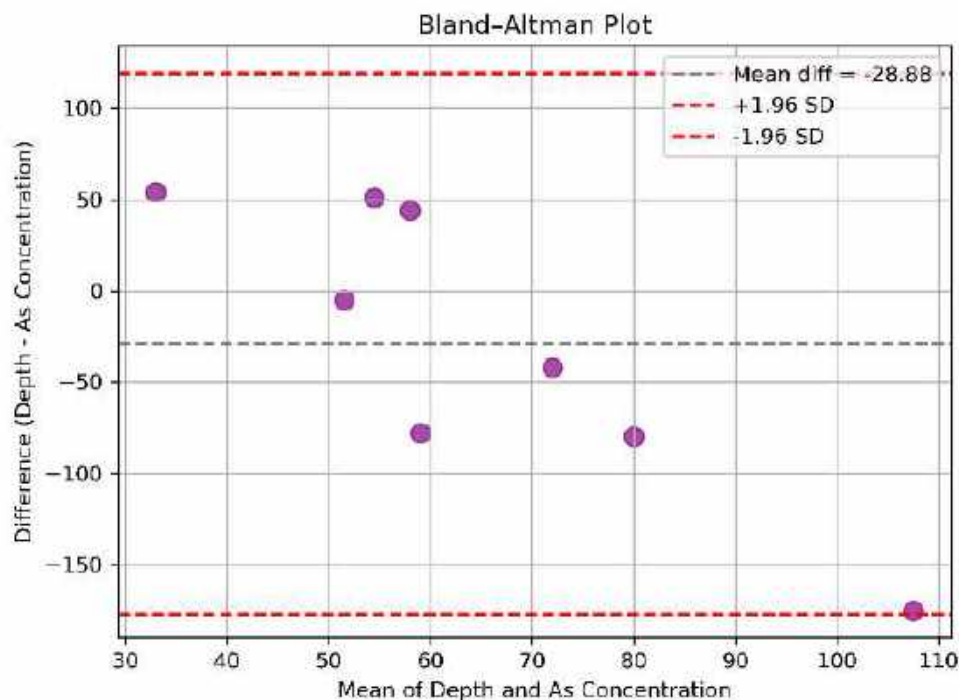
Figure 3: Bland–Altman Plot by using depth and Arsenic concentration data.

The Bland–Altman plot highlights inconsistency in the relationship, especially at shallow levels, supporting the scatter plot finding that shallow depths are associated with greater variability and higher arsenic levels.

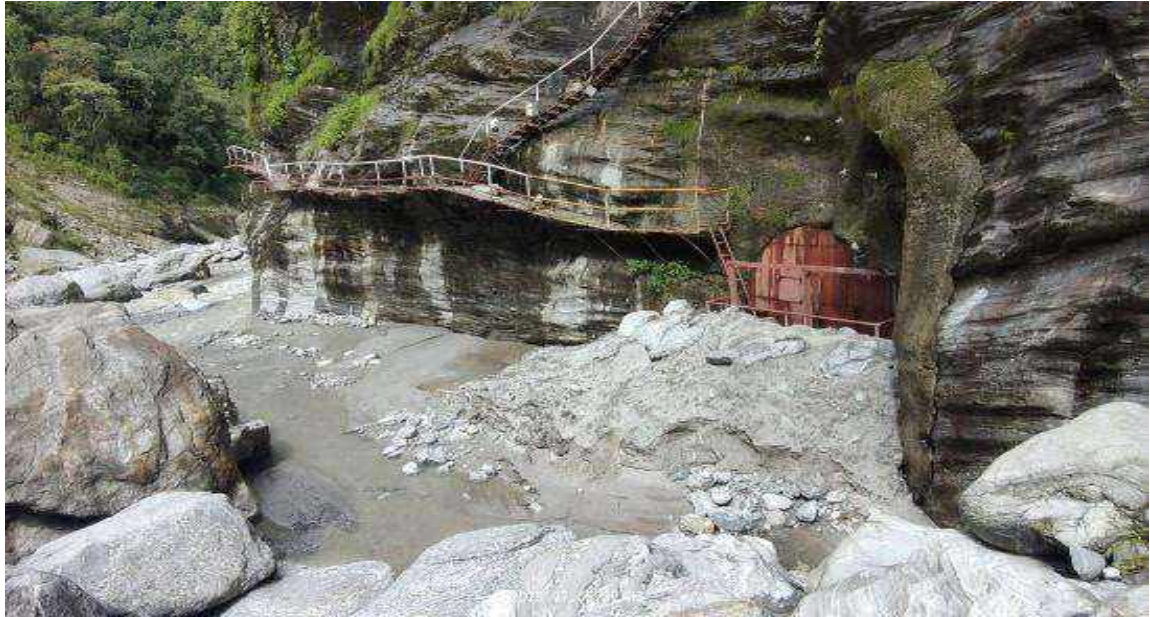
Figure 5: Water supply intake gate was disrupted by the Melamchi Flood

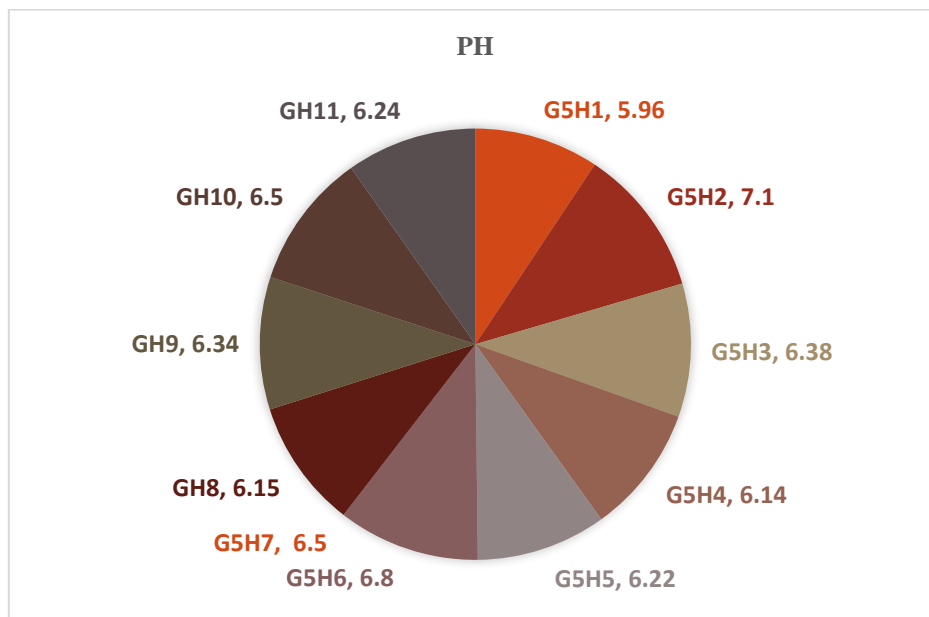
Figure 4: pH values of Madiphath sampling area

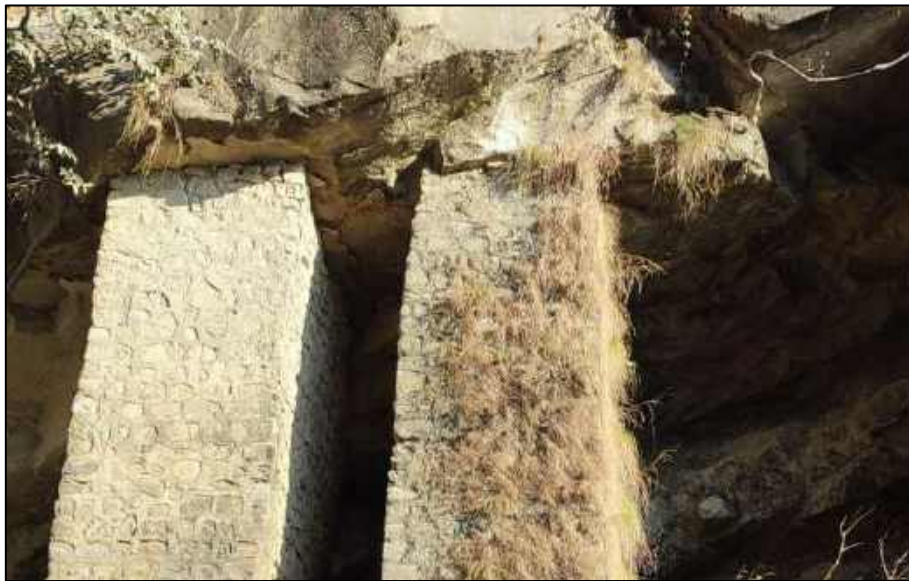
Figure 3: Photograph showing column to support hanging block, a way of mitigation rock fall.

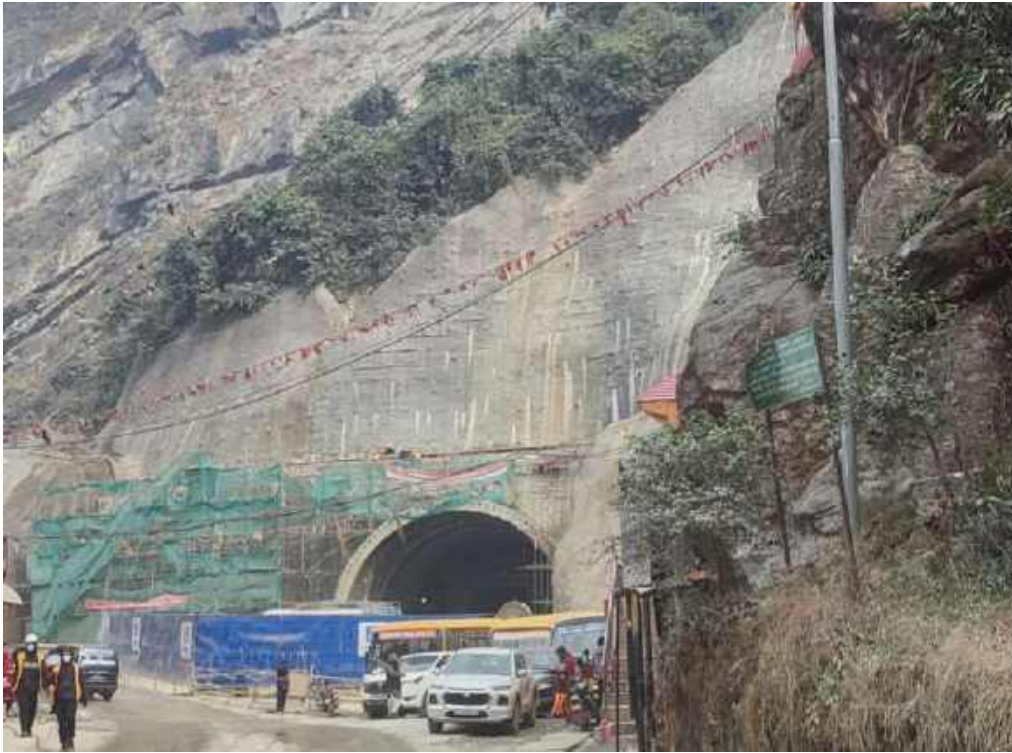
Figure 5: Photograph showing south portal of Siddhababa road tunnel

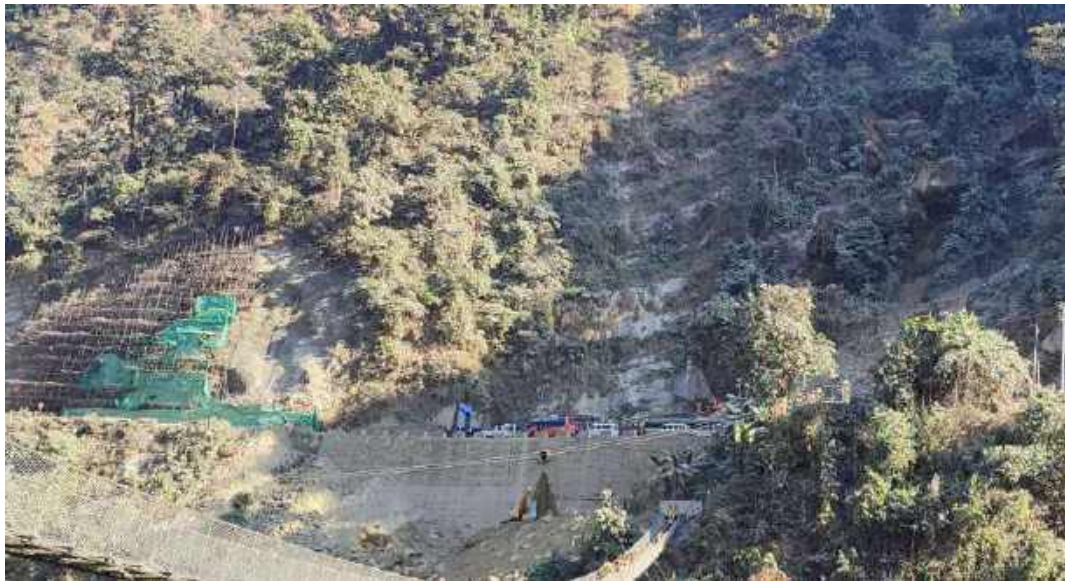
Figure 6: Photograph showing northern portal of Siddhababa road tunnel

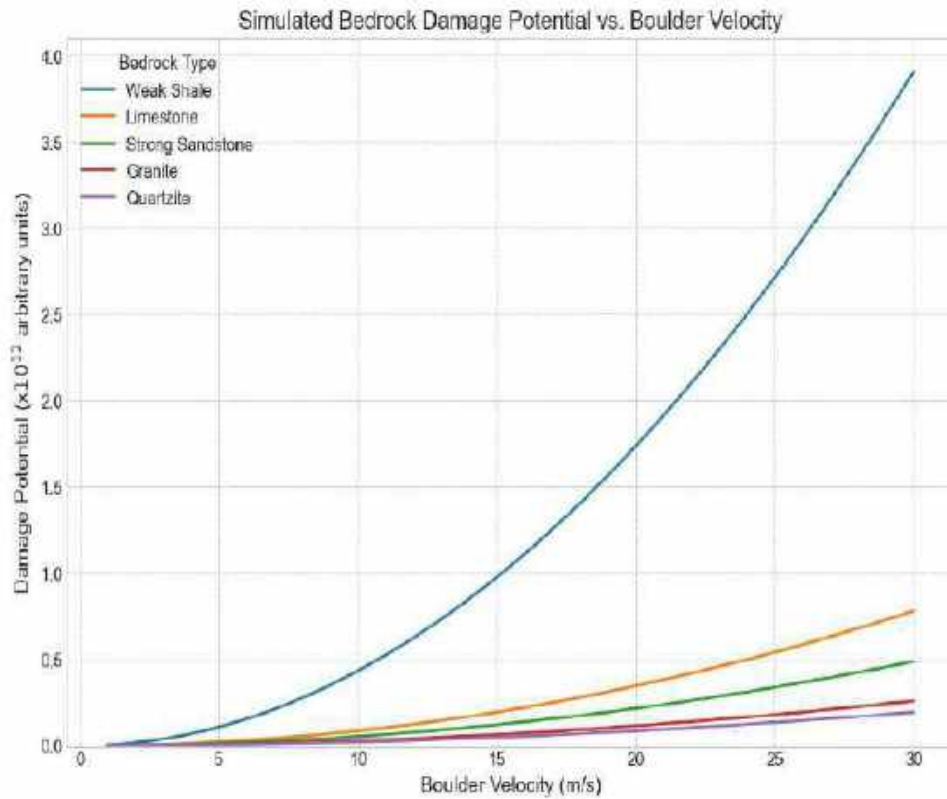
Figure 4: Theoretical relationship between boulder velocity and calculated damage potential for an 85m diameter boulder. The quadratic increase in kinetic energy leads to a catastrophic rise in erosive power at velocities typical of megafloods ($> 15\text{ms}^{-1}$).

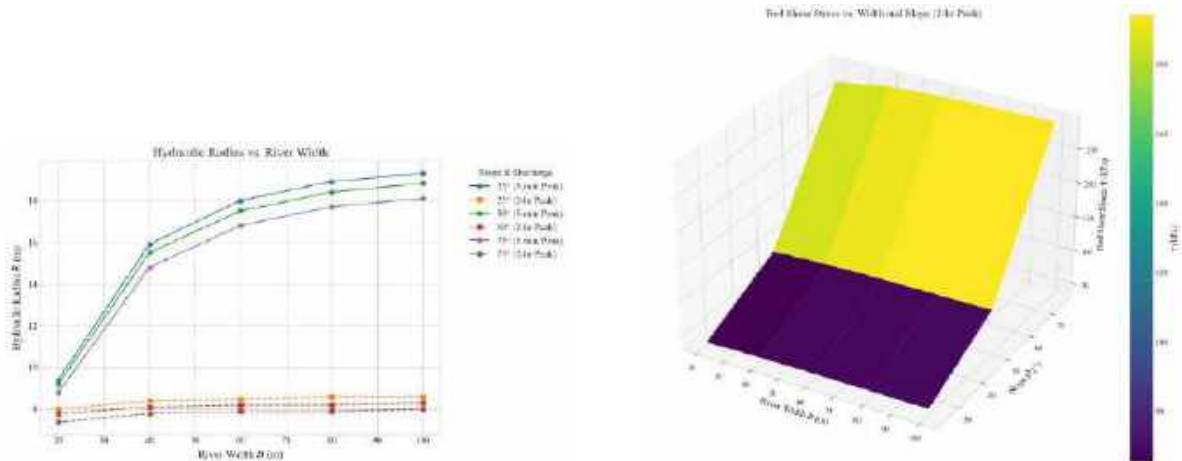
(a) Hydraulic radius vs. width for different slope angles (b) Bed shear stress vs. width and slope (2-hr peak)
Figure 5: Graphical representation of the modeled hydraulic parameters for the 2-hour peak discharge scenario ($Q_p = 12,660\text{m}^3\text{s}^{-1}$). (a) shows the relationship between channel width and hydraulic radius for various slope angles. (b) illustrates the resulting bed shear stress, demonstrating its dependence on both channel width and slope gradient.

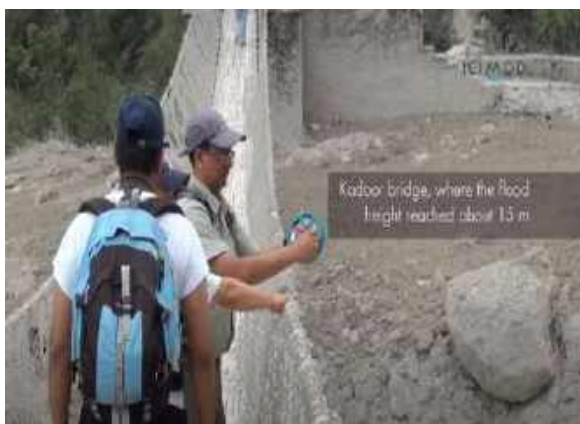
(a) 15 m height of suspension bridge destruction

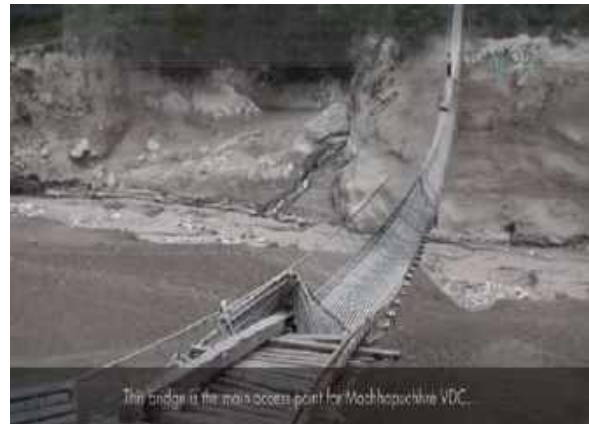
(b) Main bridge damage in Machhapuchhre VDC
